## Protected Tree Report

Dekel Bitton  
6107 Rhodes Ave.  
North Hollywood,  
Ca 91606

**Subject: Protected Tree Report for New Home Construction and Lot Split**

**APN# 2333011034**

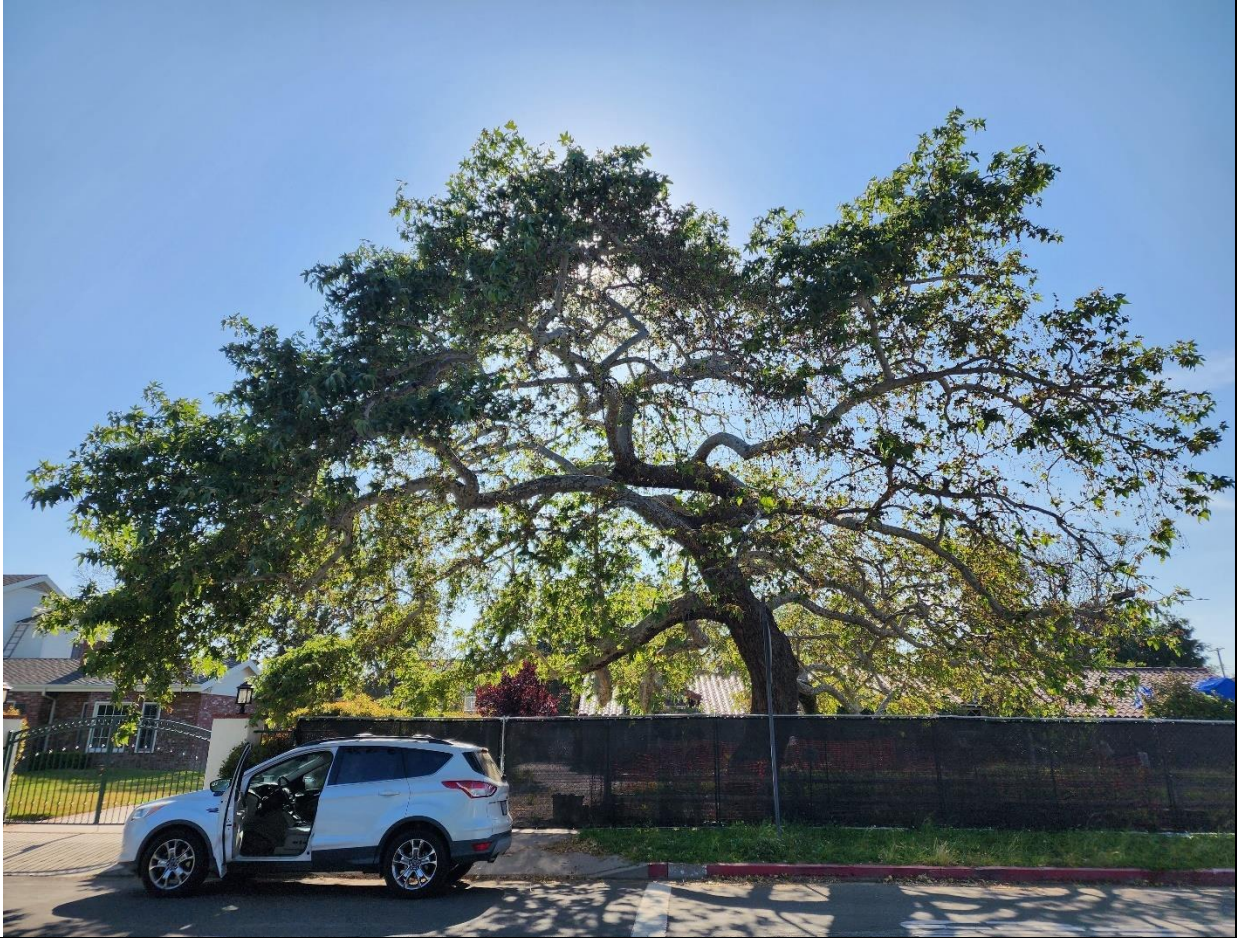
Inspection photo of subject property from Rhodes Ave. (4/28/2023)

Sycamore tree #1 visible here.

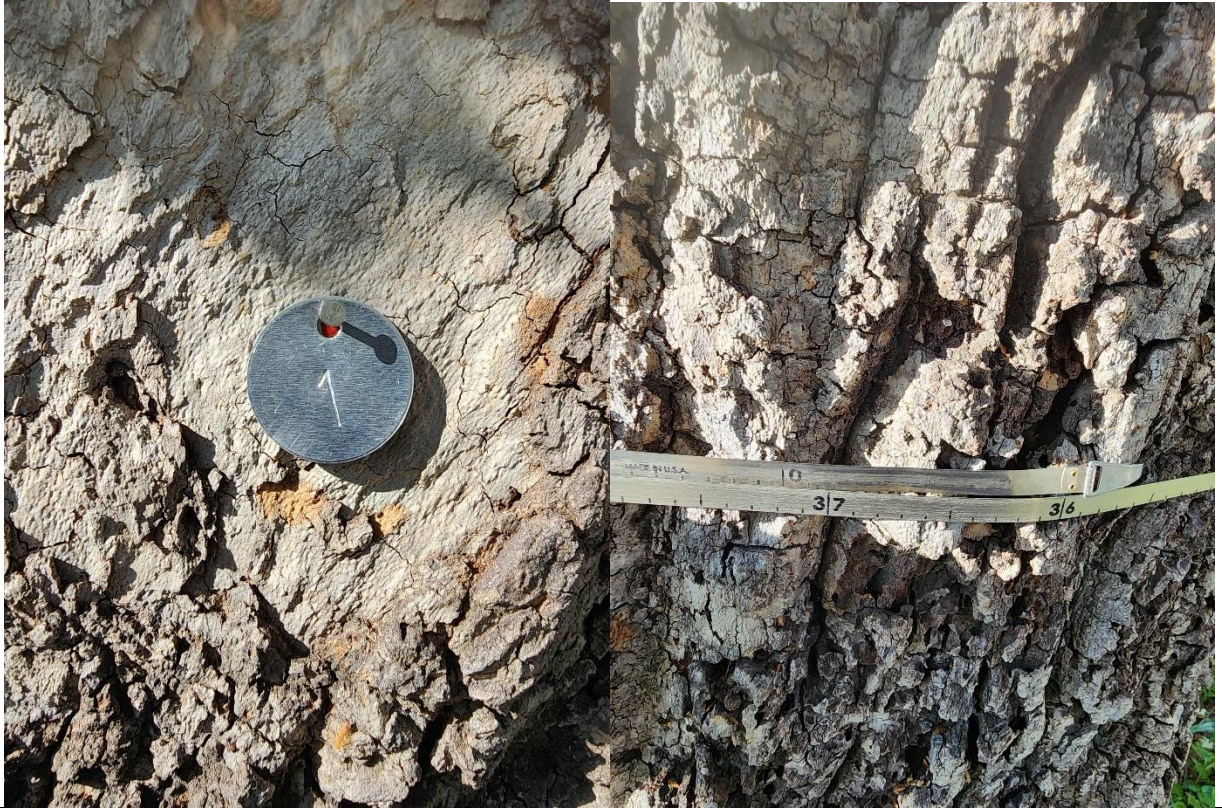
California Sycamore Tree #1 tag and DBH

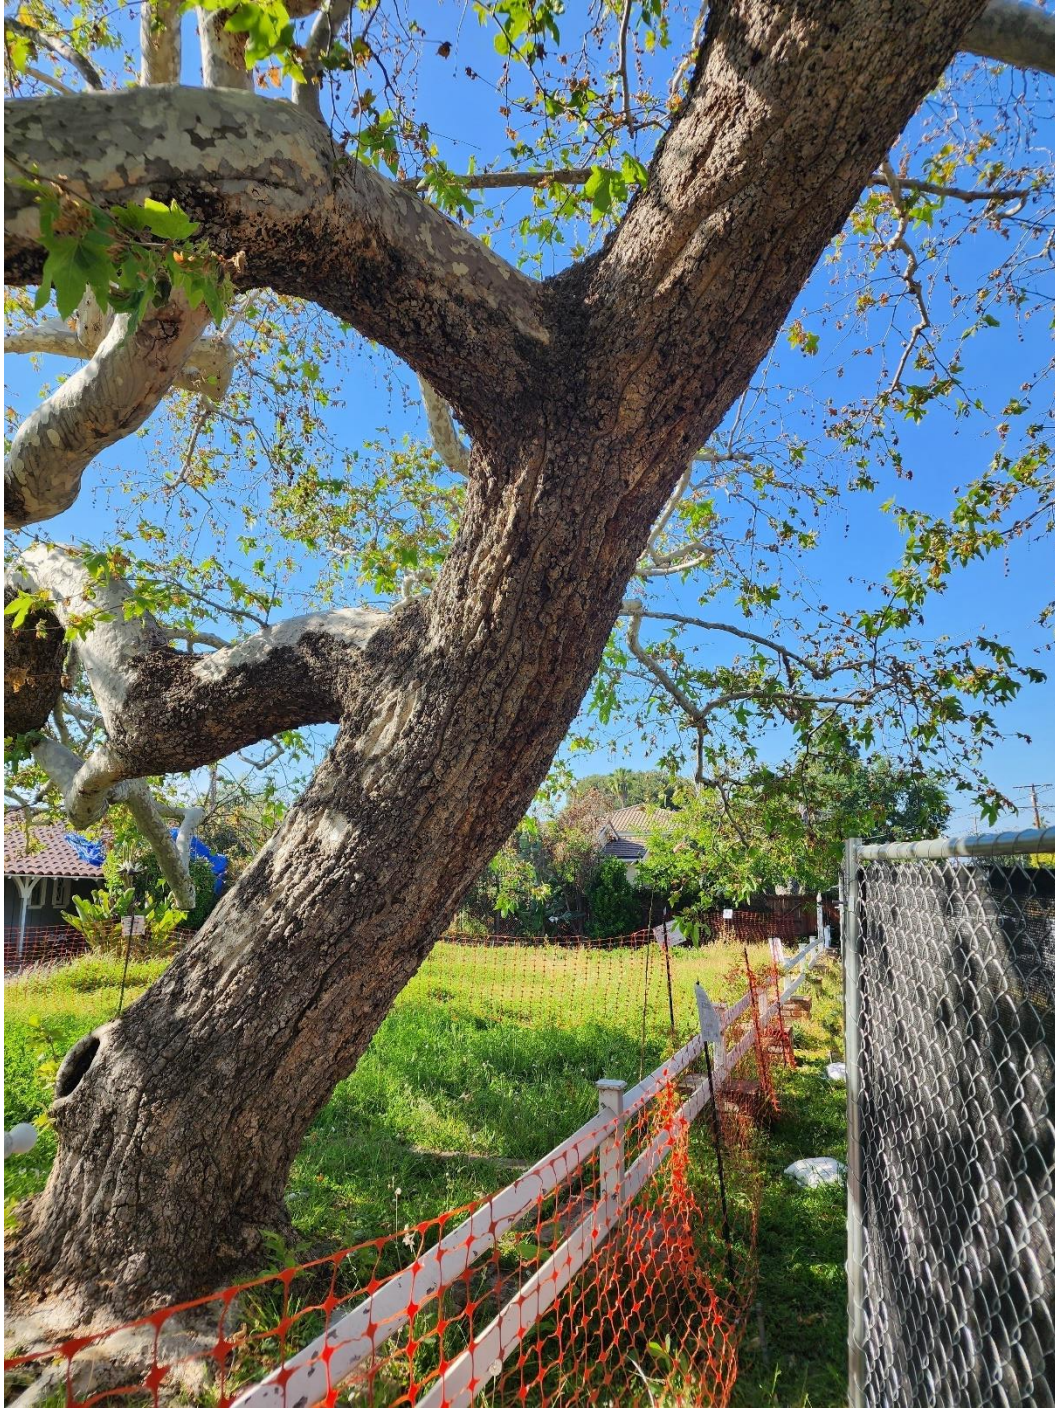
Tree#1 has a significant lean towards the street

**Canopy trimming:** The Sycamore has a sprawling shape where the canopy spread is much wider than the tree is tall. The trunk of the tree is also leaning towards the street. In order to provide some short-term mitigation of some degree of tree failure risk, it is recommended that the tree have a canopy reduction pruning. The goal of this type of pruning would be to shorten the reach of the over-extending lateral branches to force the tree to remain compact and exerting less leverage of the trunk and on the branch attachments.

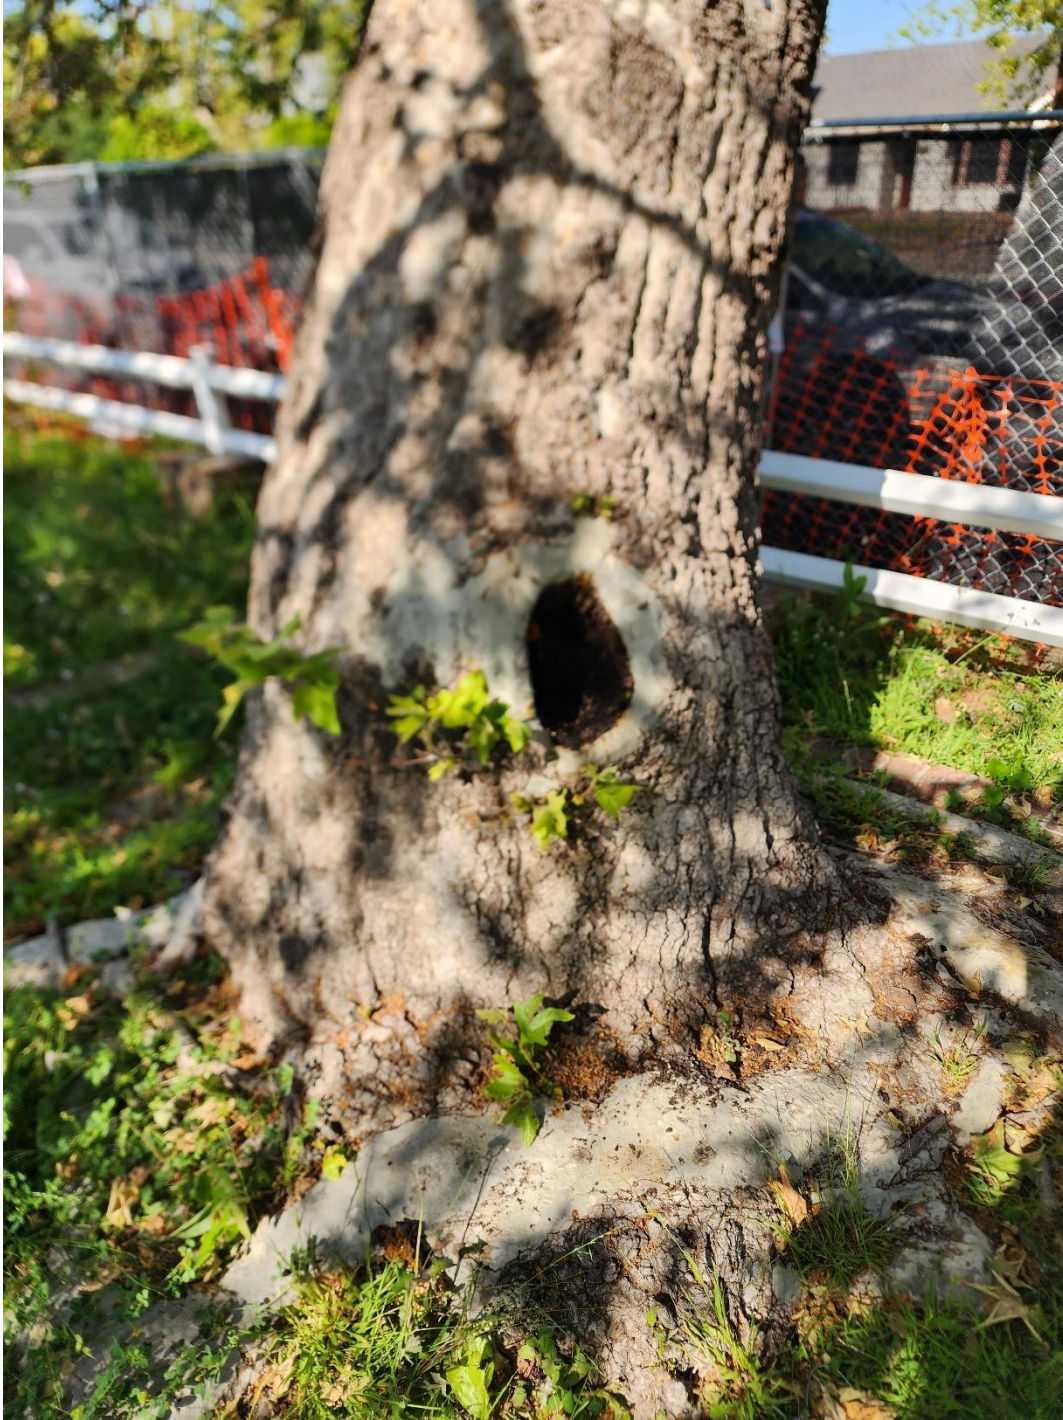
Tree #1 has a significantly deep cavity at the base of the trunk. It also has a very shallow root buttress. Trees with this unusual root flare sometimes are very shallow rooted and do not have a deep penetrating root system.

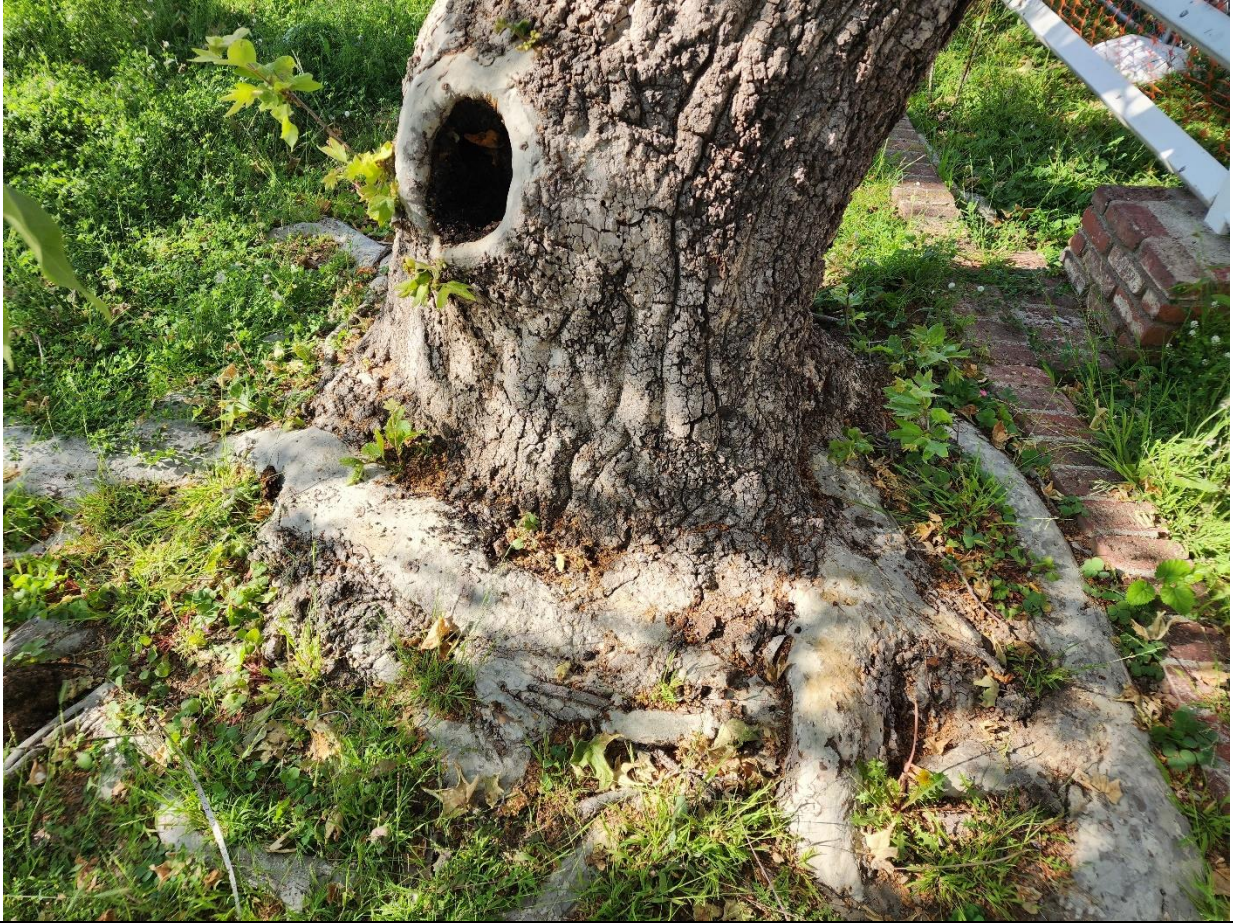
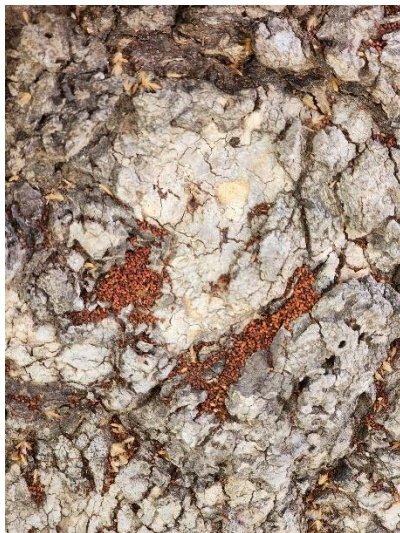
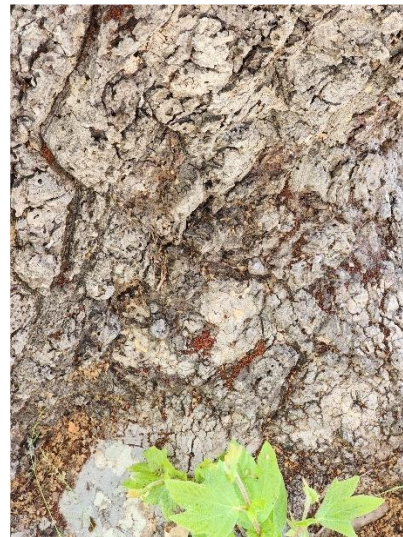
Alt view of cavity and root flare. Also noticeable is the substantial 'frass' and borer activity at the base of the tree (below).

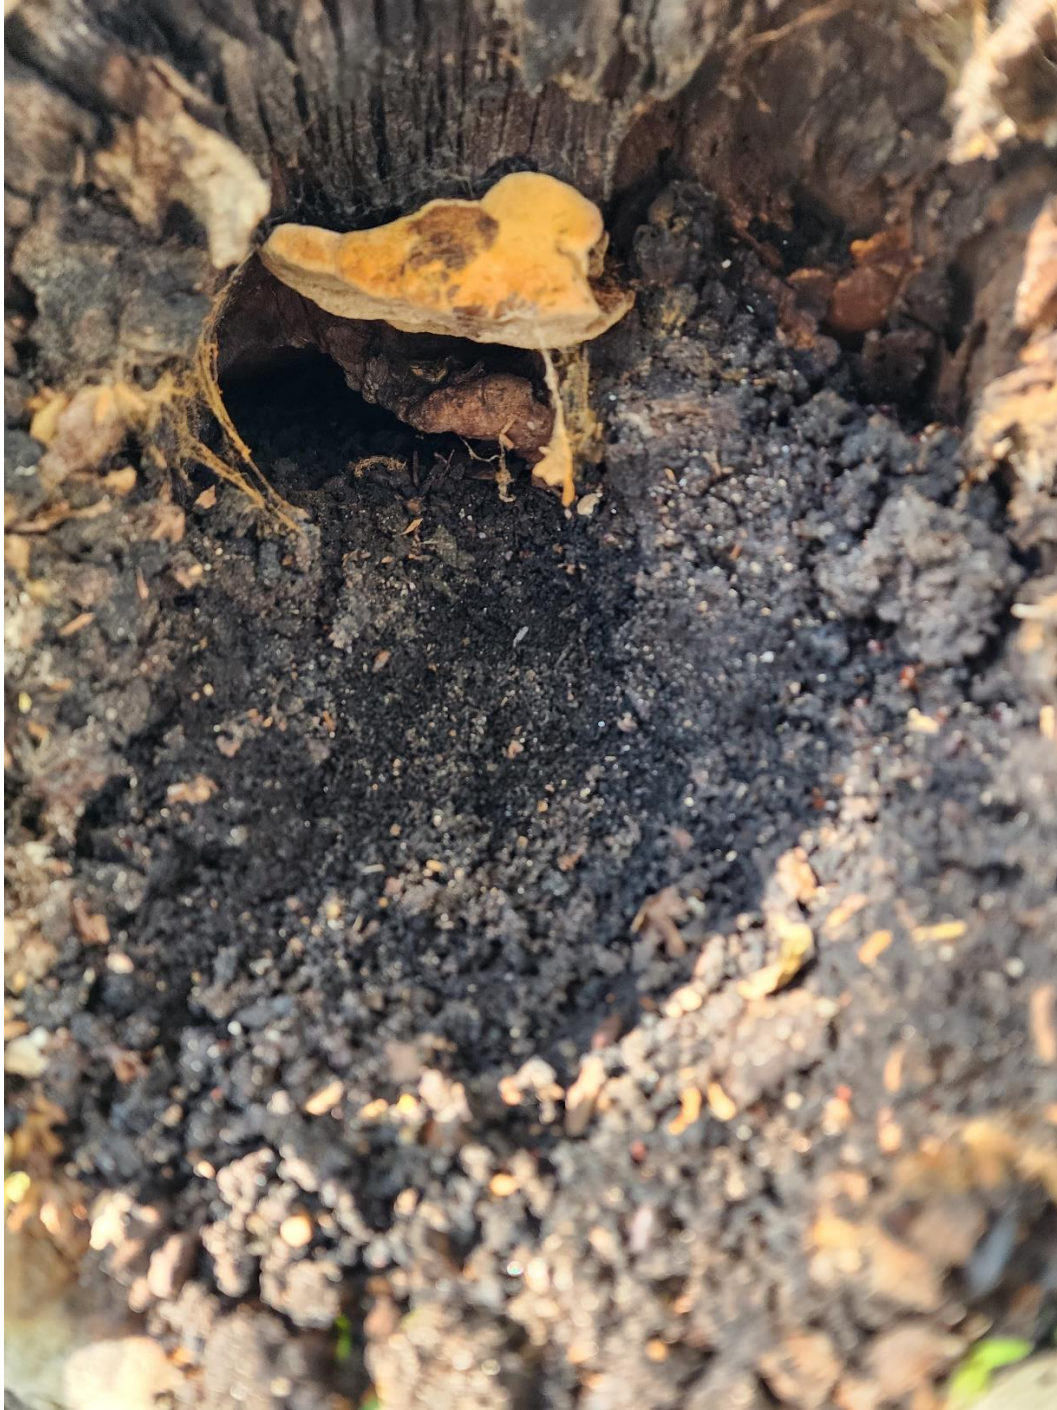
View of cavity interior with fungal fruiting body.

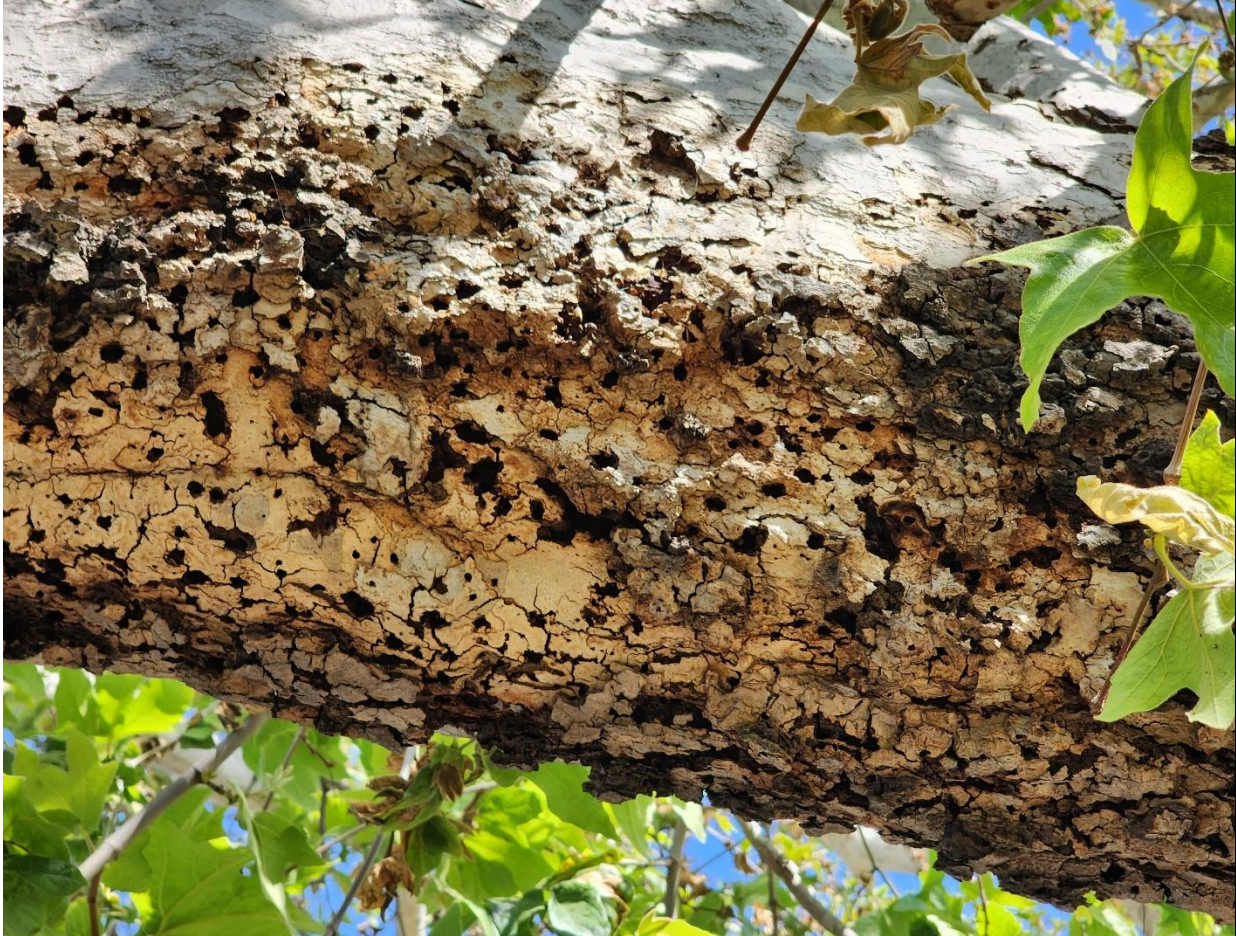
Significant Borer activity not only in the lower trunk but also in the upper scaffold branches and branch unions.

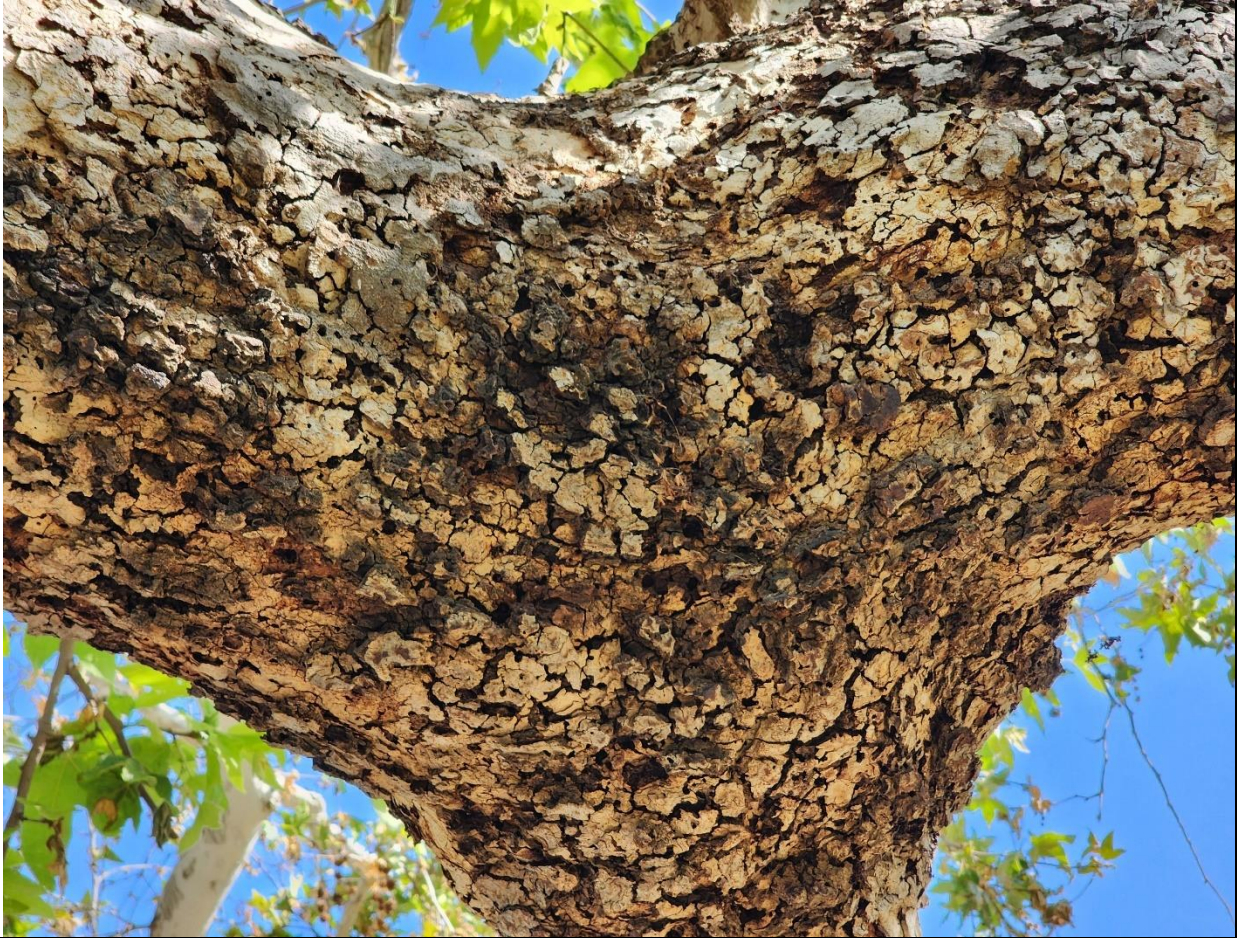
Significant Borer activity not only in the lower trunk but also in the upper scaffold branches and branch unions.

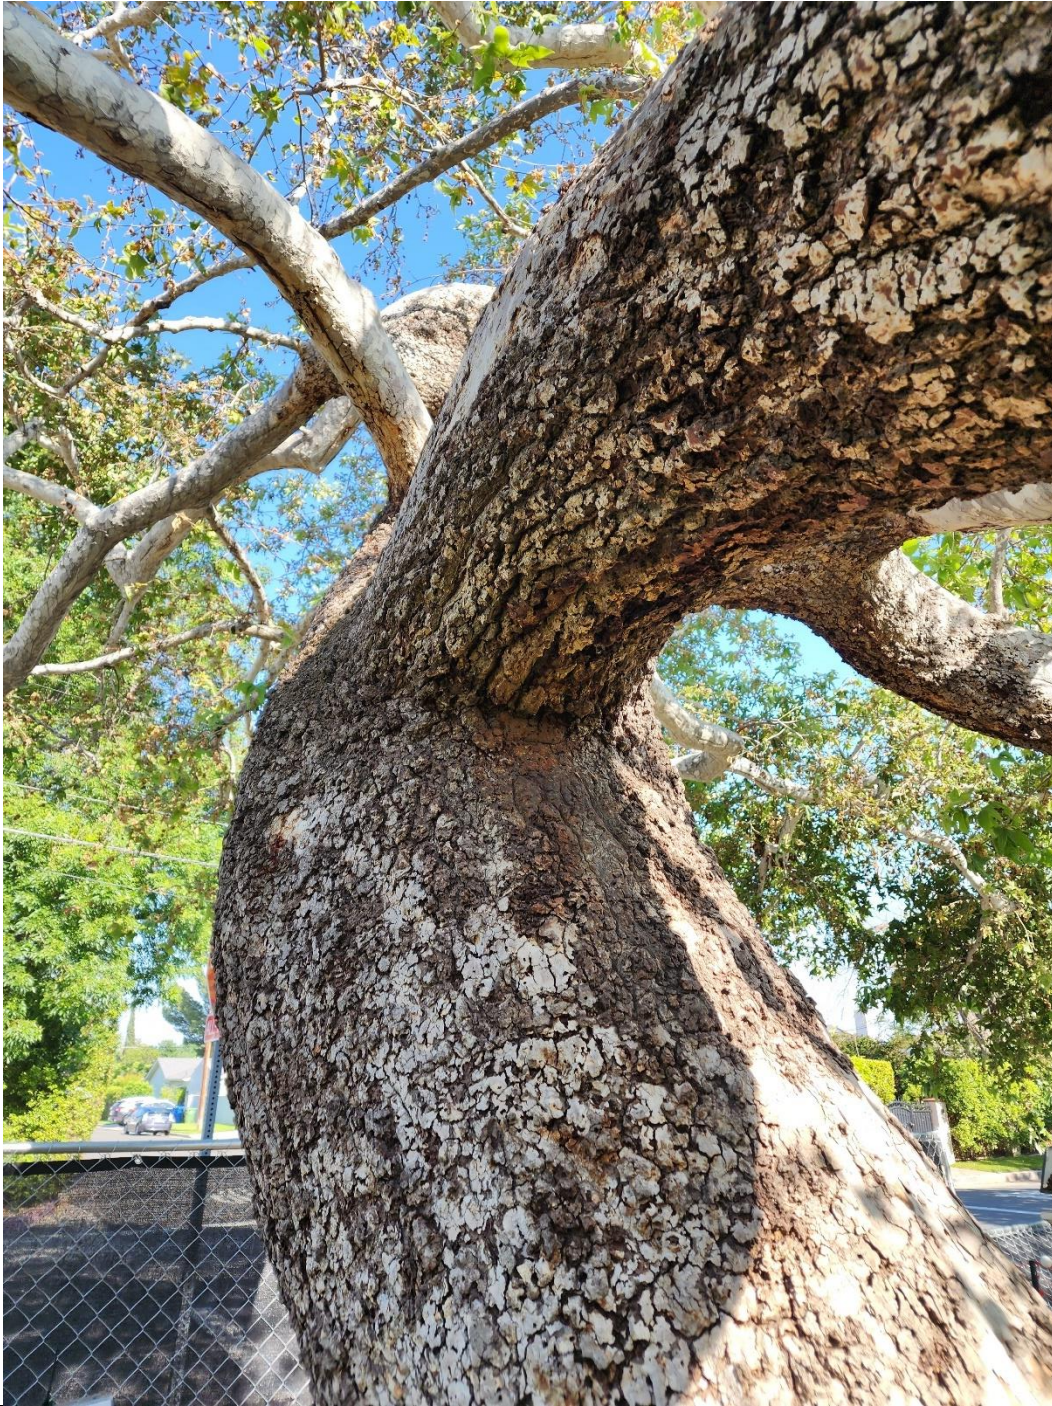
Significant Borer activity not only in the lower trunk but also in the upper scaffold branches and branch unions.

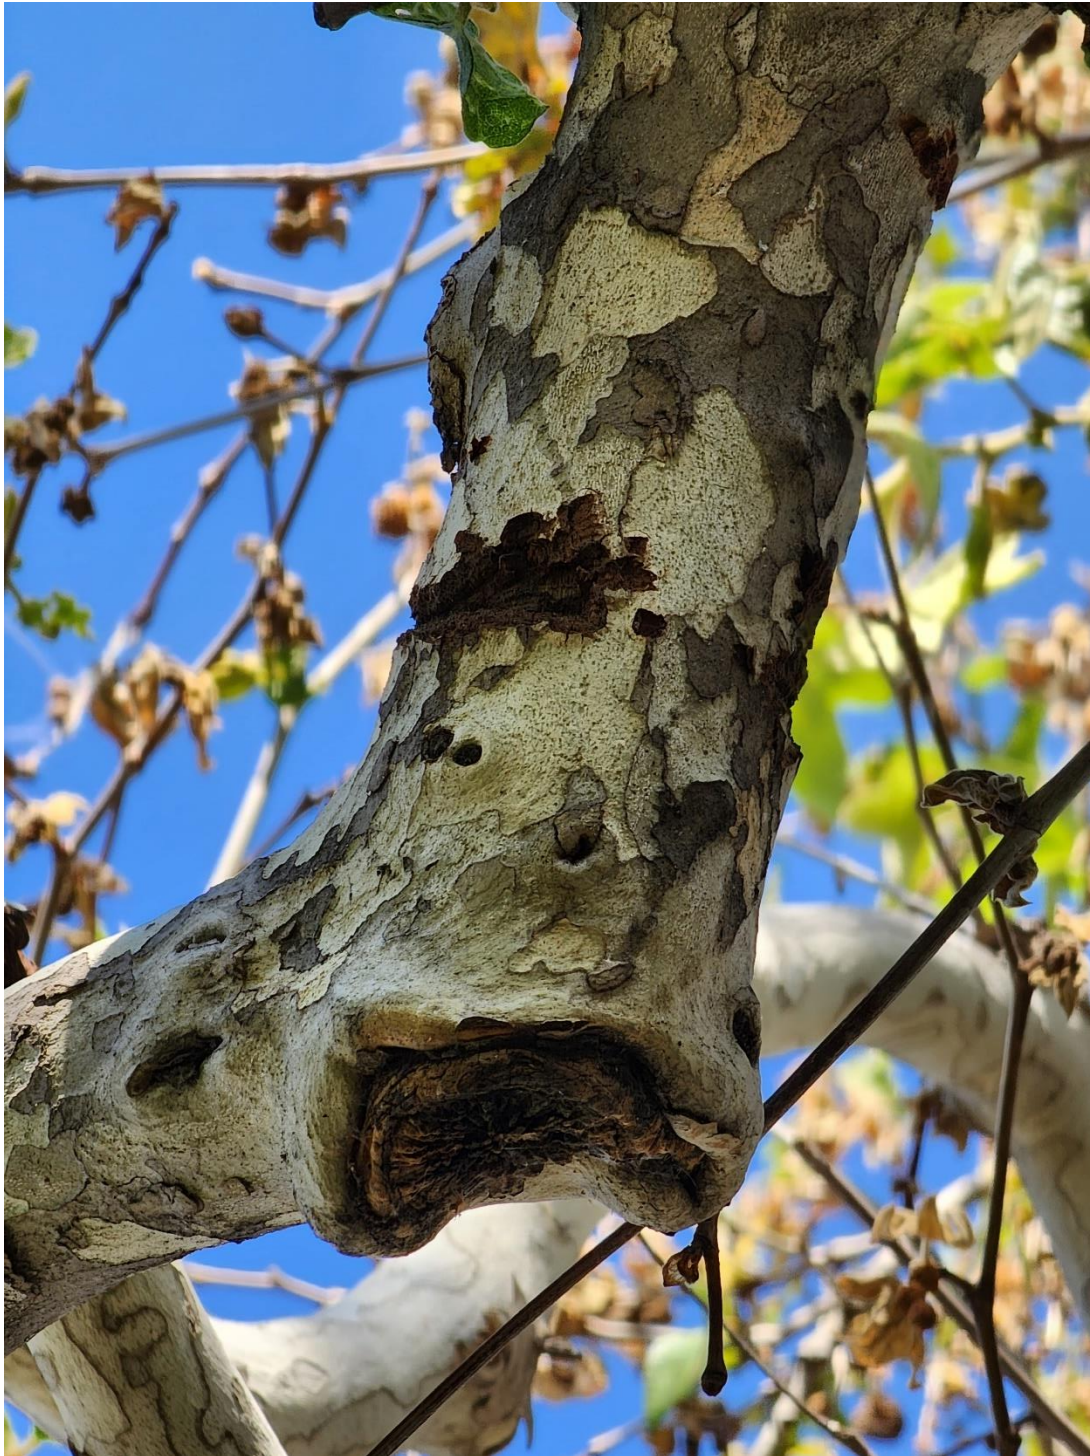
Signs of decay in branch elbows, staining, and borer entry holes visible.

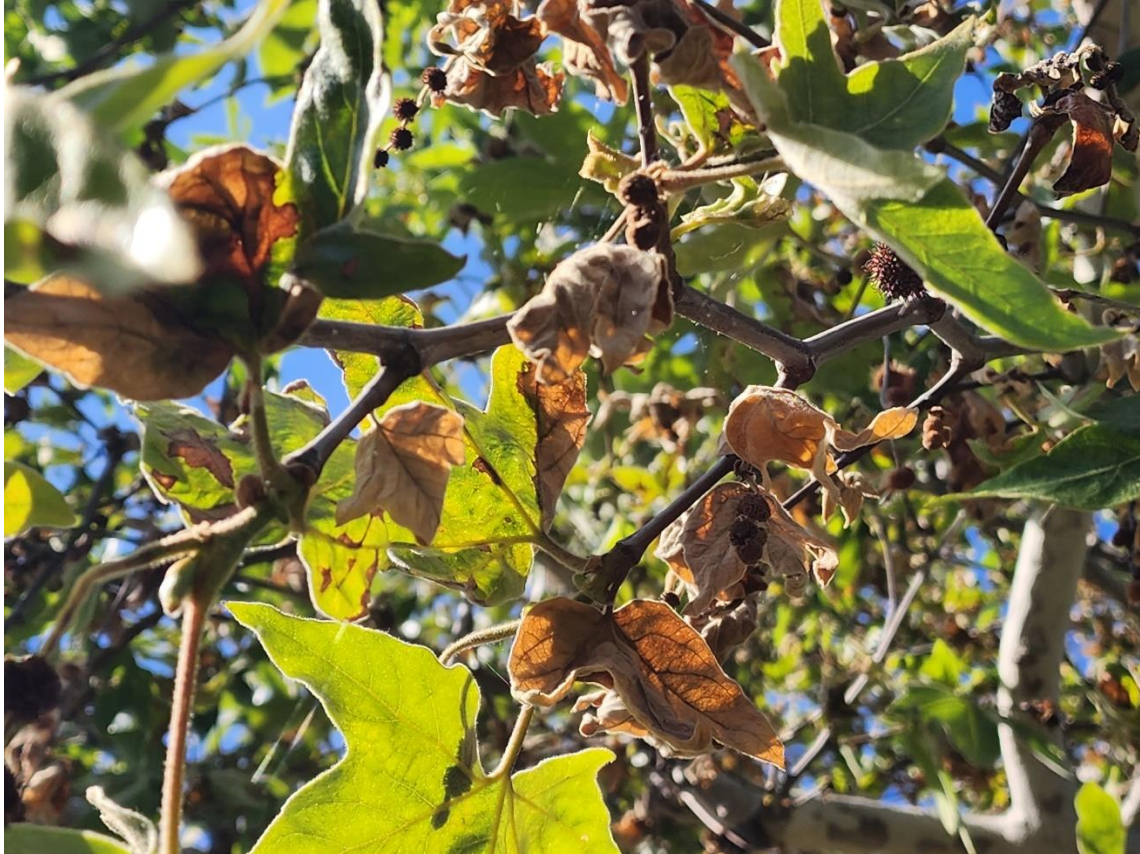
Leaves are severely affected by Anthracnose fungus which is weakening the tree by depleting photosynthesis.

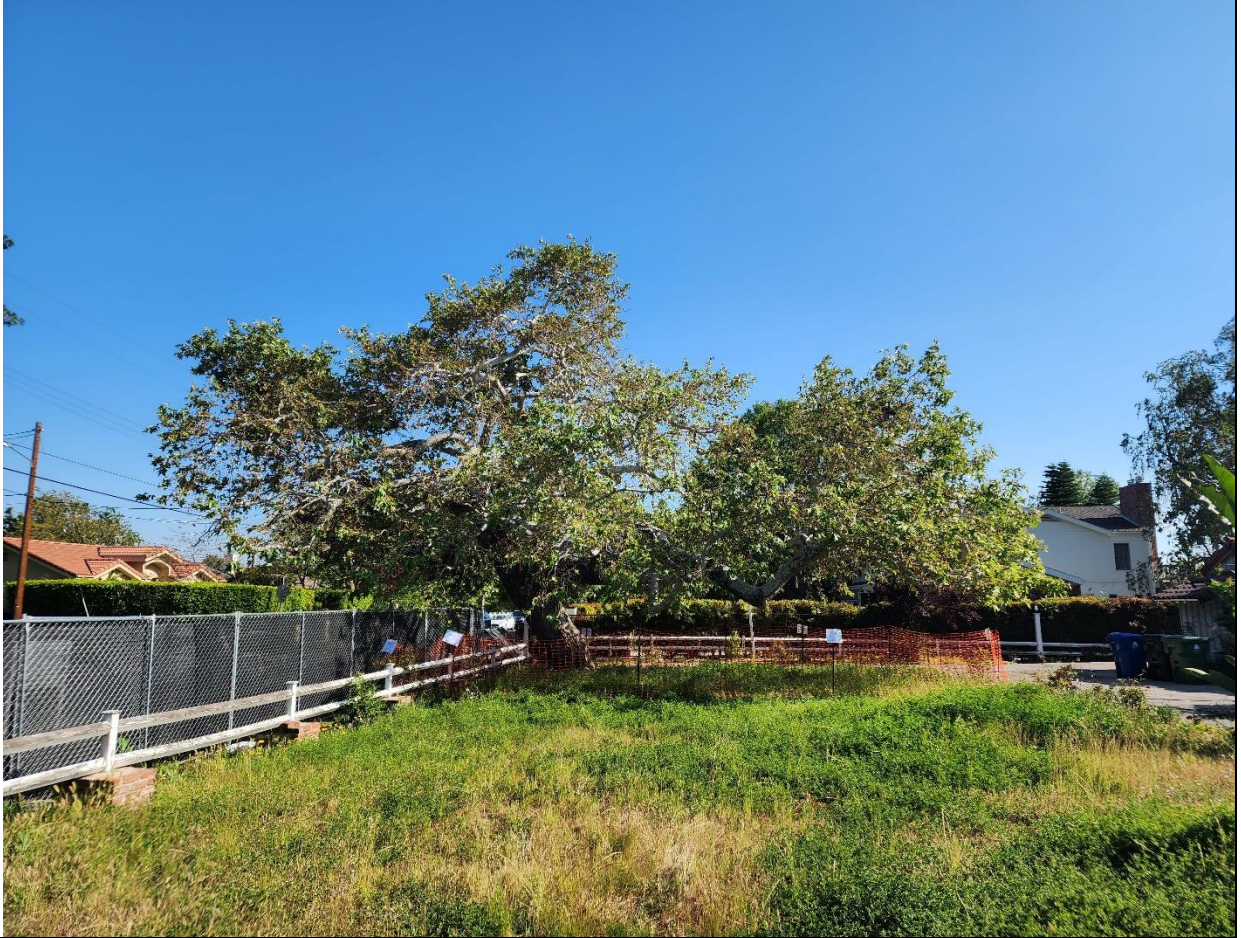
Protective root zone fencing installed.

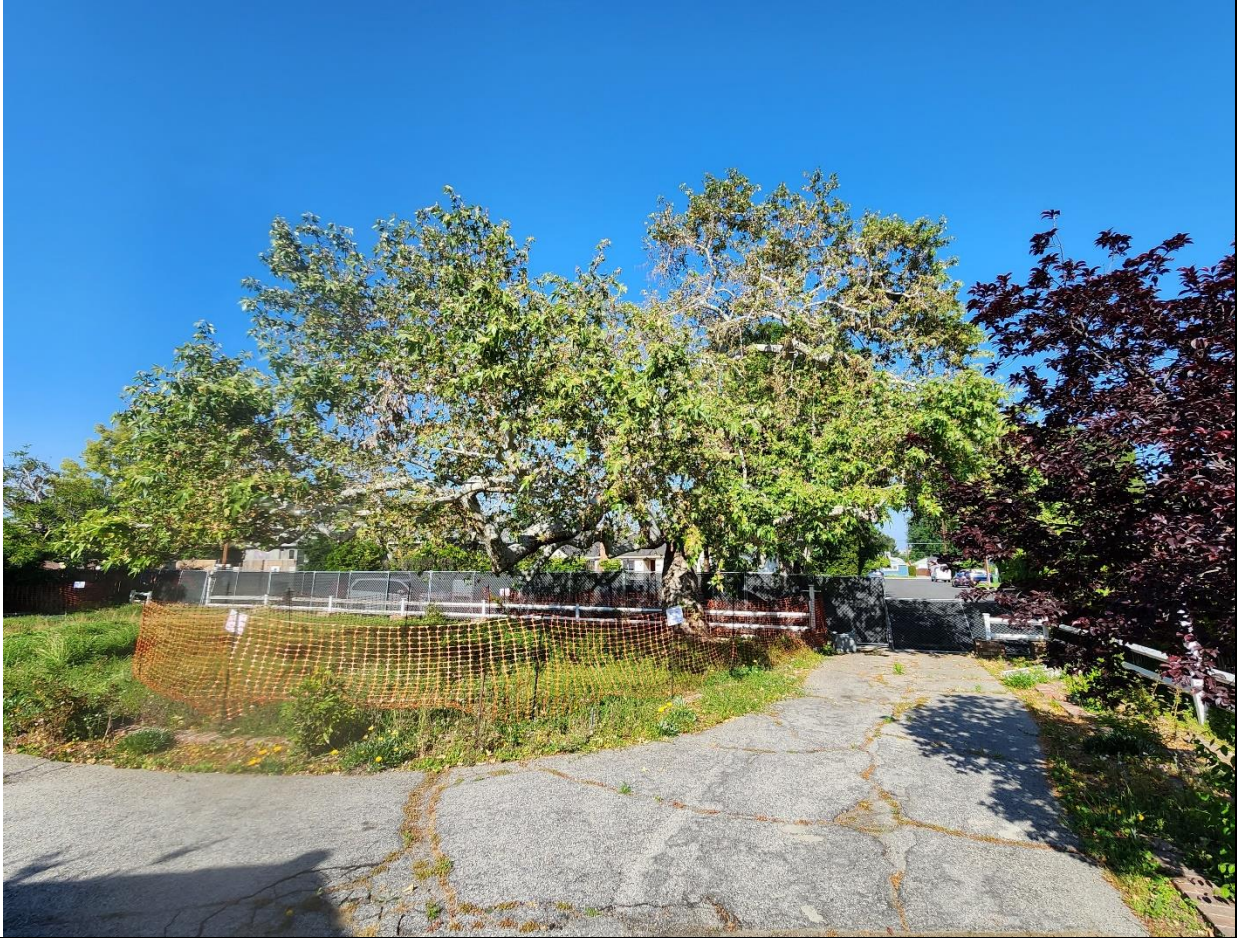
Protective root zone fencing installed.

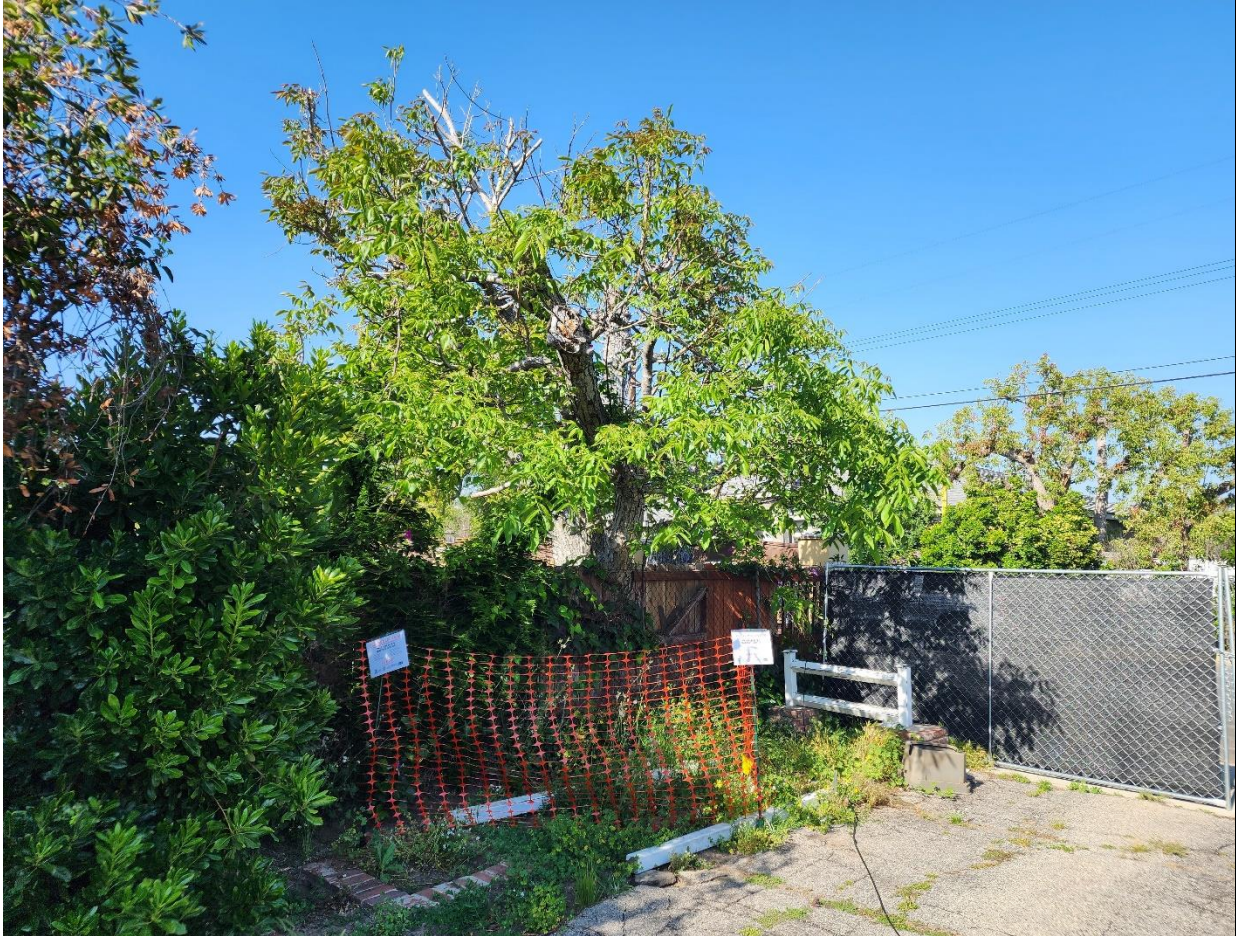
Off-site Walnut tree has fencing to protect any encroaching roots.

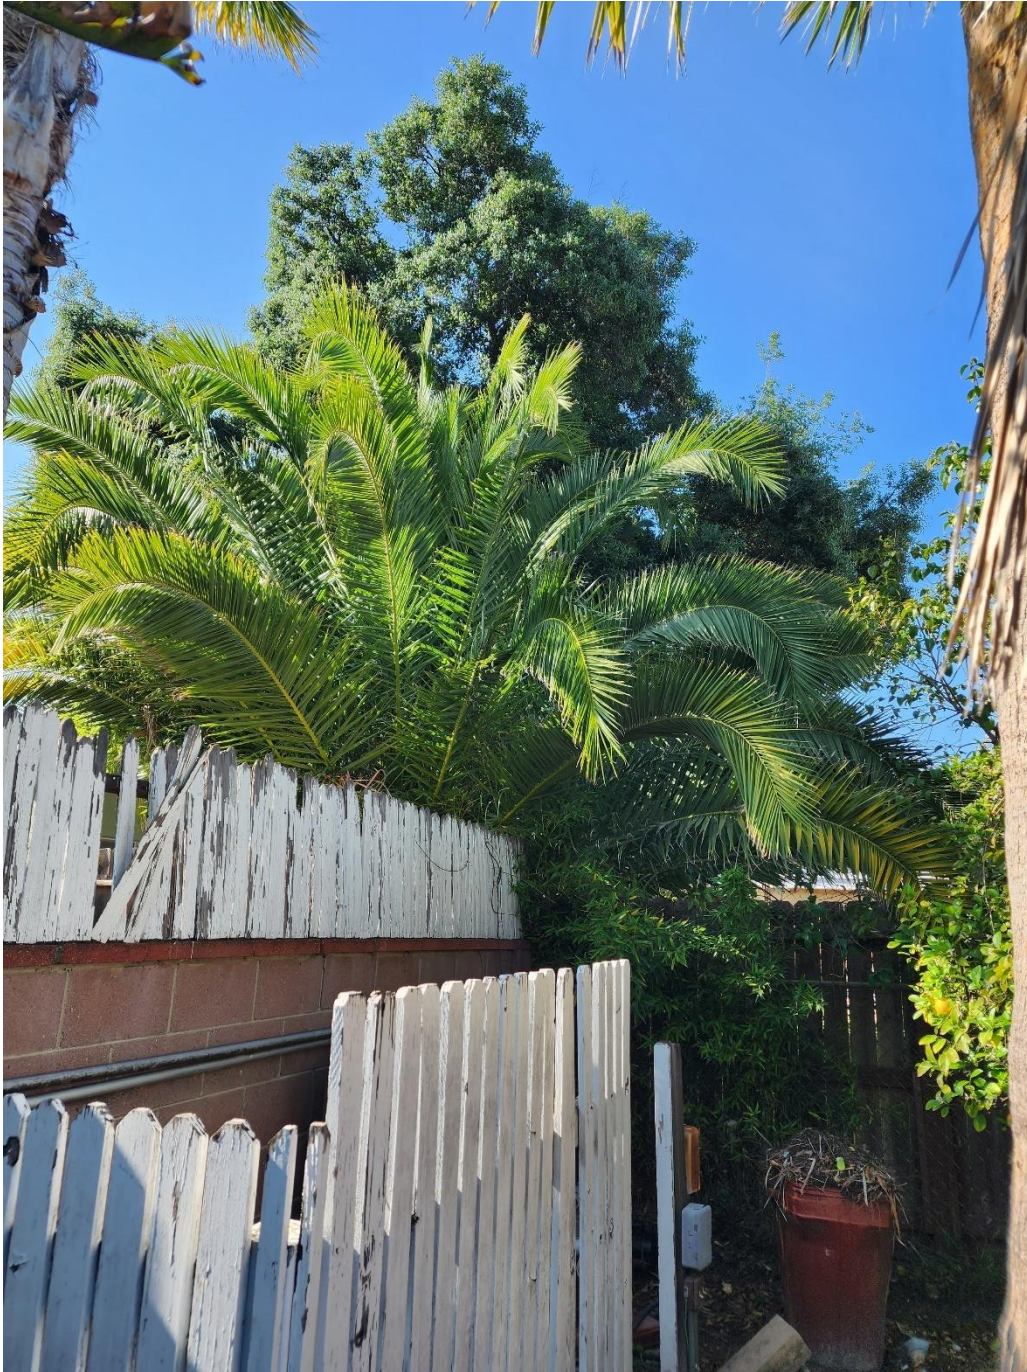
Off-site Coast Live Oak well out of construcion impact area. NW rear corner.
