## Protected Tree Report

Dekel Bitton  
6107 Rhodes Ave.  
North Hollywood,  
Ca 91606

**Subject: Protected Tree Report for New Home Construction and Lot Split**

**APN# 2333011034**

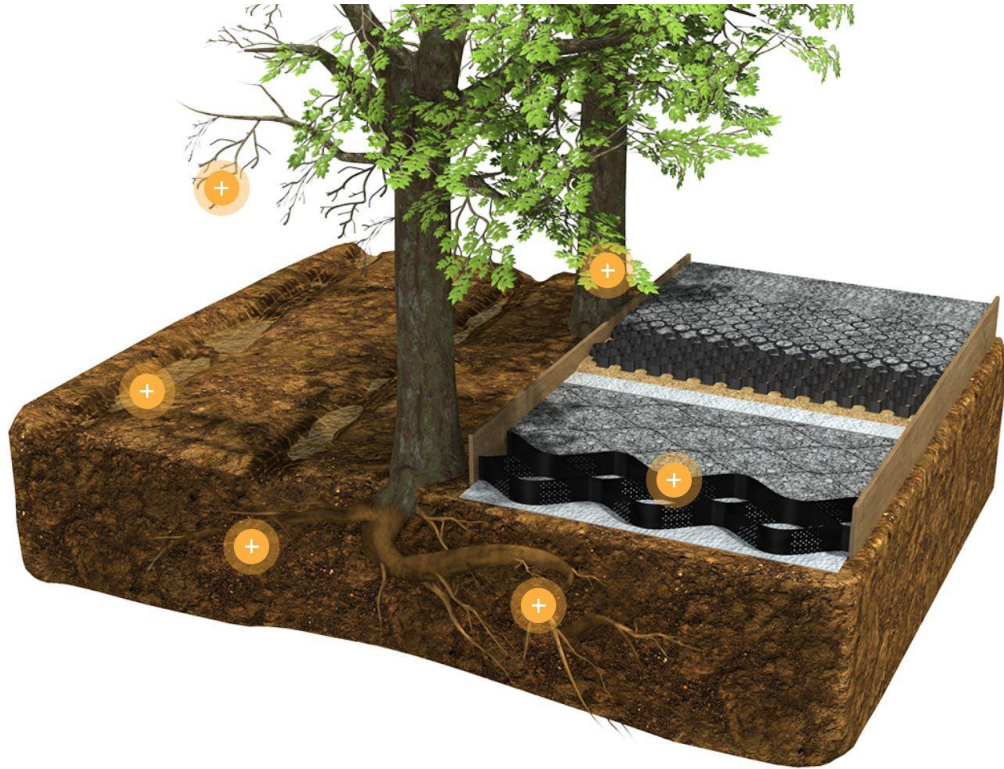
#### NO DIG SOLUTION

Example of tree root preservation with no digging while allowing for pavers to be installed over roots. A technique like this or similar is proposed for implementation to preserve the tree.

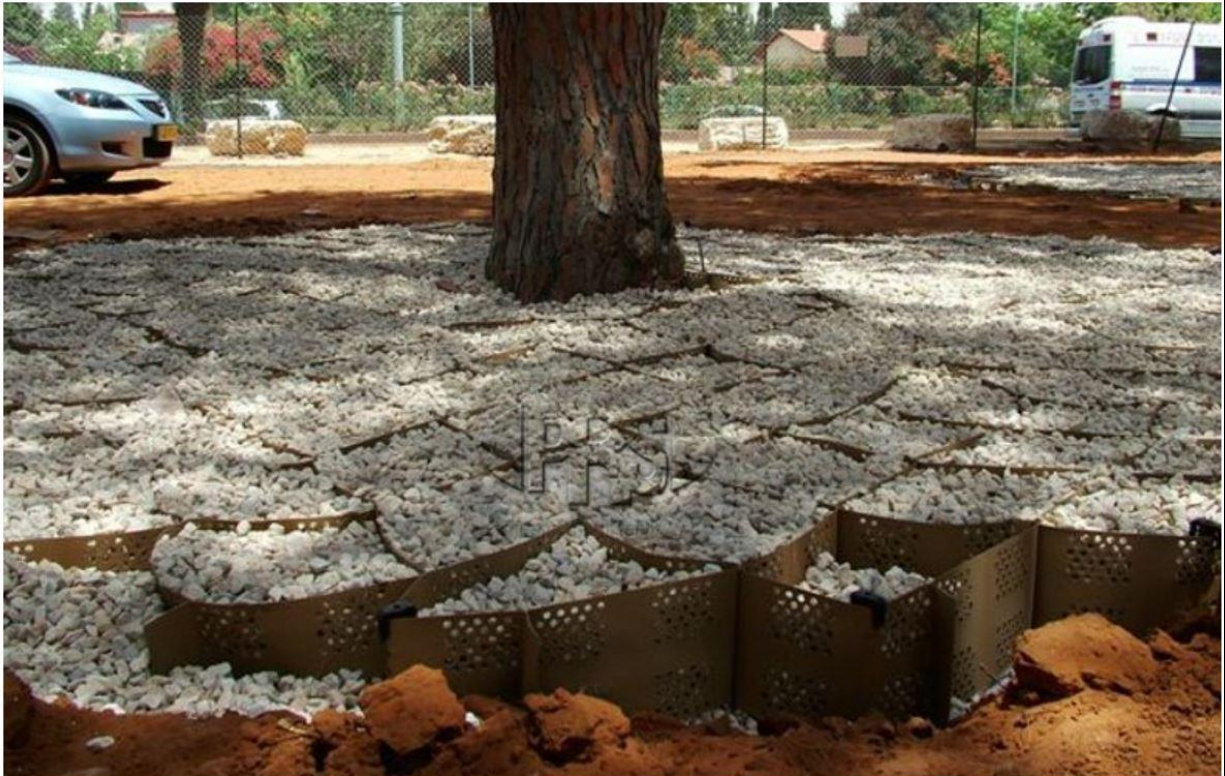
## Neoloy Soil Protection

The Neoloy 3D cellular confinement system is ideal soil protection and ground reinforcement solution for tree protection zones. Not only does Neoloy provide physical protection for the root layer. Neoloy Tough-Cells also increase the soil bearing capacity and distributes traffic loads laterally.

By reducing stresses to the subsurface soil structure, Neoloy prevents soil compaction and damage to tree roots. Neoloy Tough-Cell confinement also maintains the integrity of uncompacted infill, preventing abrasion and erosion of fines, thereby limiting degradation of the surface layer.
